## **INVESTIGATION OF PIPELINES' FAILURE PROBLEM OF ELSHABAB PUMPING STATIONS**

**Salah El-Din Sayed Mohamed**

Dr., National Water Research Center, Mechanical and Electrical Research Institute,  
Delta Barrage, Egypt

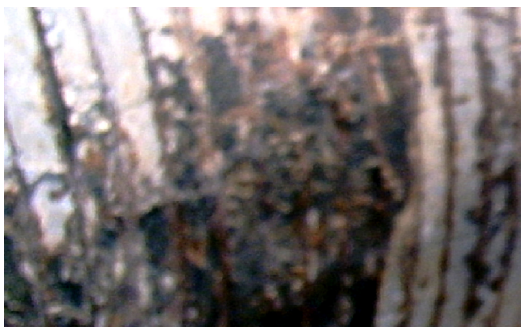
Figures 3 and 4 show parts of a corroded pipeline. Figure 5 shows iron bars inside part of a corroded pipe. Figure 6 shows an iron bar which is supposed to be inside the pipeline. The pipeline was destroyed in this part and the pre-stressed concrete bar was found above the ground surface. Figure 7 shows part of a corroded pipe.

**Fig. 3 Part of a corroded pipe**

- 1- A good drainage system should be carried out in the area to decrease the water table.
- 2- The corroded parts of the pipelines should be replaced.
- 3- The designed protection and monitoring system should be implemented to monitor and protect the pipelines and to overcome the failure problem.
- 4- The pipeline should be protected with a mish of metallic bond under the medium and high voltage transmission lines.

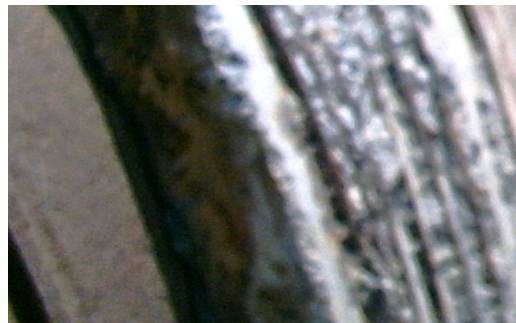
**Fig. 4 Part of a corroded pipe**

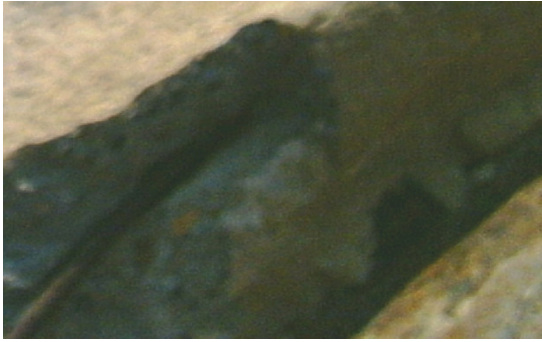
**Fig. 5 Iron bars inside pipeline**

The values of potential measurements in different locations of soil were ranging between 0.6 - 0.65 volts. To be safe from corrosion, the value of the potential shouldn't be less than 0.85 volts. But the measuring values were between 0.6 and 0.65 volts, so the pipeline was in the corrosive environment. The steel in concrete was subjected to corrosion mechanism. Rust was formed in the steel bars, it expanded, the concrete began to crack. The expansion of steel bars was continued until the outer concrete were completely destroyed [4].

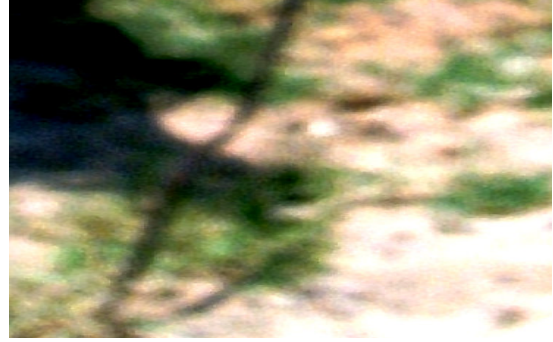
**Fig. 6 Iron bar on the ground surface**

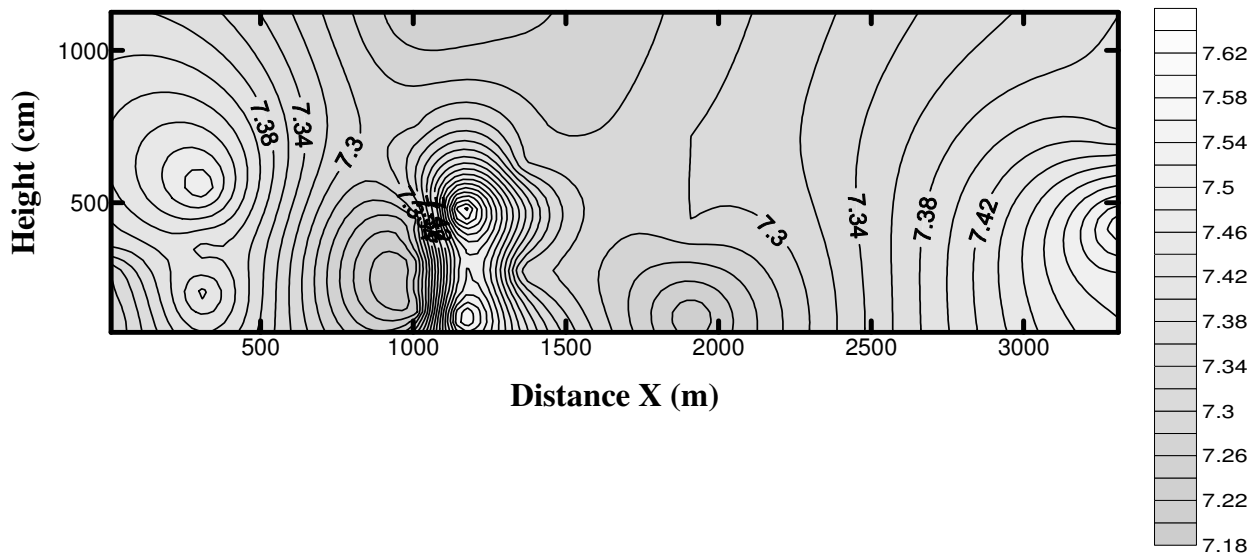
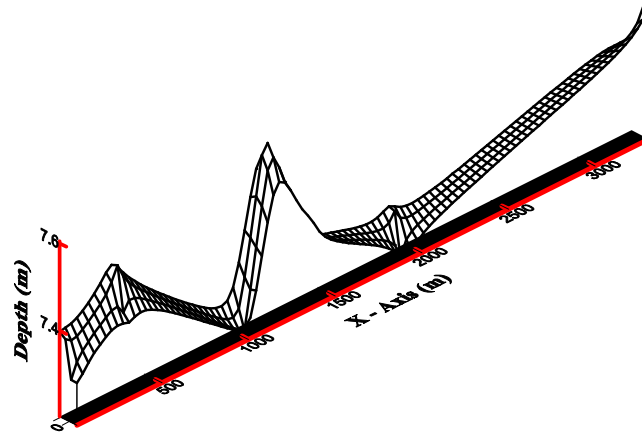
The measurements of the acidity and alkalinity pH are shown in Figures 8 and 9. Their values were between 7.3 – 8.6. These values mean that the soil is quite alkaline. This leads to increasing the corrosion rate. The maximum values of pH were at about 1200 meters from the bridge carrying pipes and at a depth of about 6 meters.

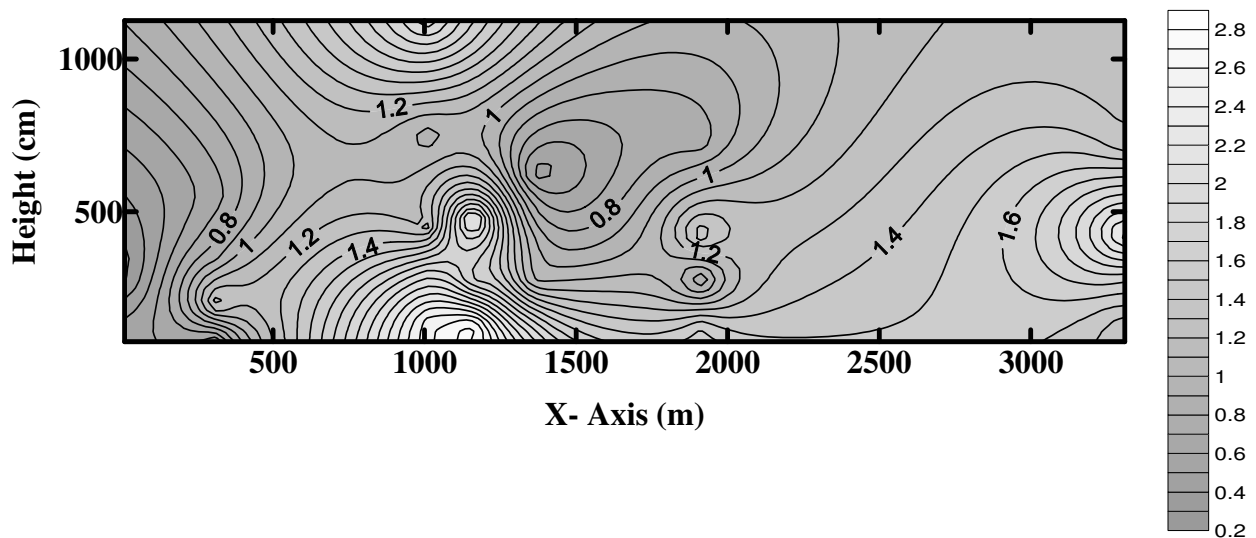
Fig. 11 Electrical Conductivity Distribution

The measurements of the electrical conductivity are as shown in Figure 11 and their values are ranging between 0.2 to 2.8. The values lead to an increase in the corrosion rate.

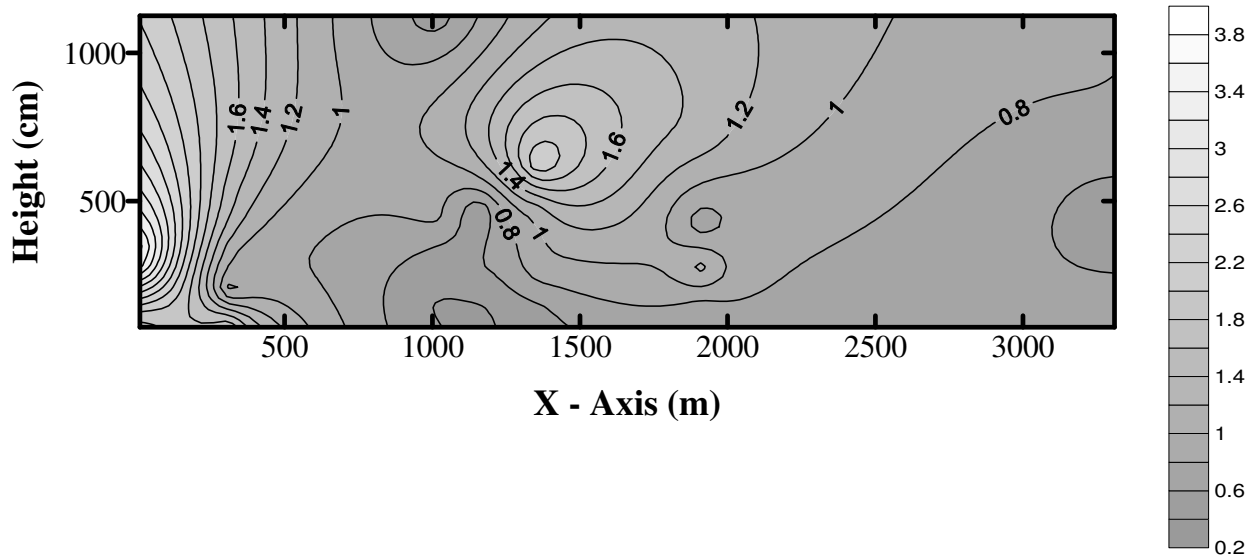
**Fig. 12 Electrical Resistivity Distribution**

The measurements of the soil resistivity are as shown Figure 12 and their values are ranging between 0.2 to 3.8. According to Figure 13 which indicates the relation between the soil resistivity and the corrosion rate [9], the soil resistivity values are found in the extremely corrosive zone. The low values of soil resistivity increase the corrosion rate rapidly.

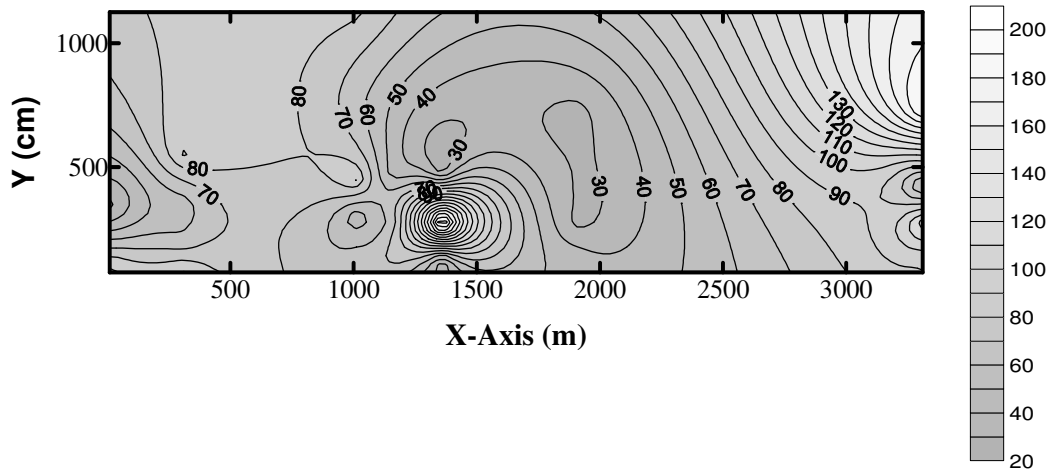
**Fig. 15 Cloride Distribution**

According to Figure 15, the Chlorides' values rang between 27 to 210 ppm. This amount of chlorides causes an increase in the corrosion rate.

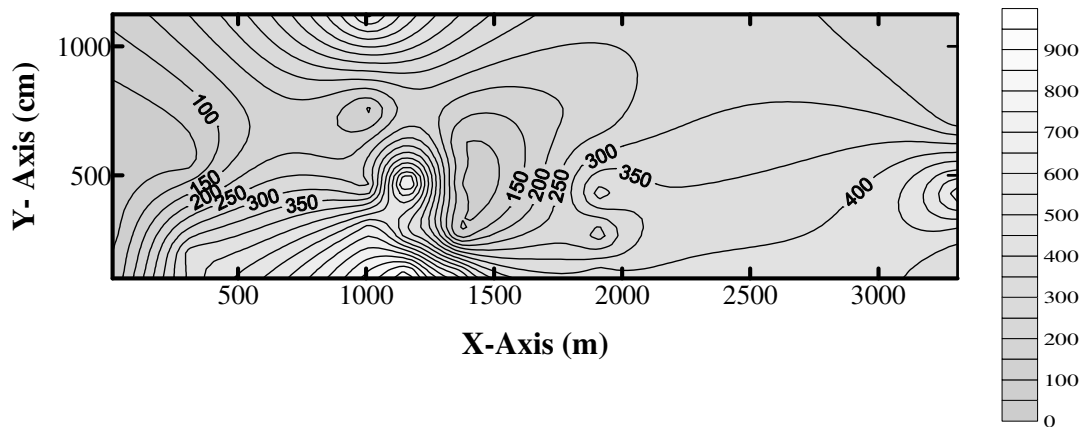
**Fig. 16 Sulfide Distribution**

According to Figure 16, the amount of sulfides ranges between 30 to 930 ppm. This amount of sulfides causes an increase in the corrosion rate.

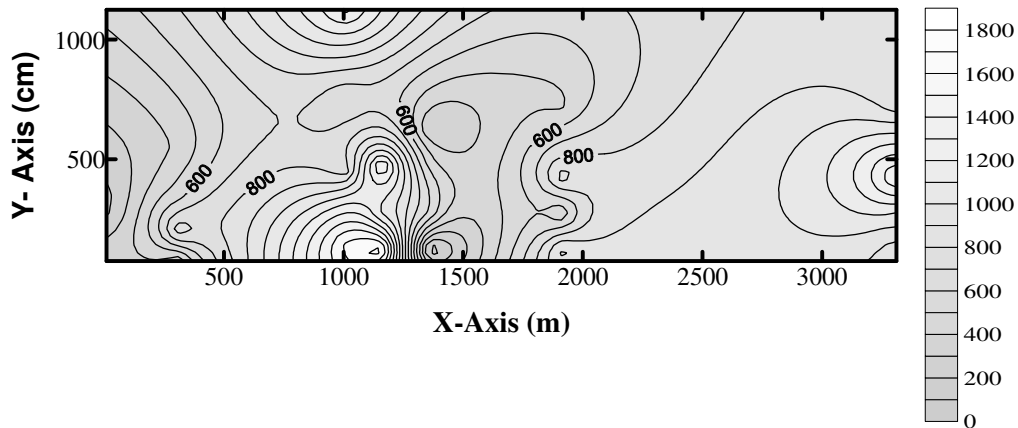
**Fig. 17 TDS Distribution**

According to Figure 17, the amount of the total dissolved salts TDS ranges between 175 to 1760 ppm. This amount of dissolved salts leads to decrease in the soil resistivity which causes an increase in the corrosion rate. Also dissolved salts increase the soil conductivity.

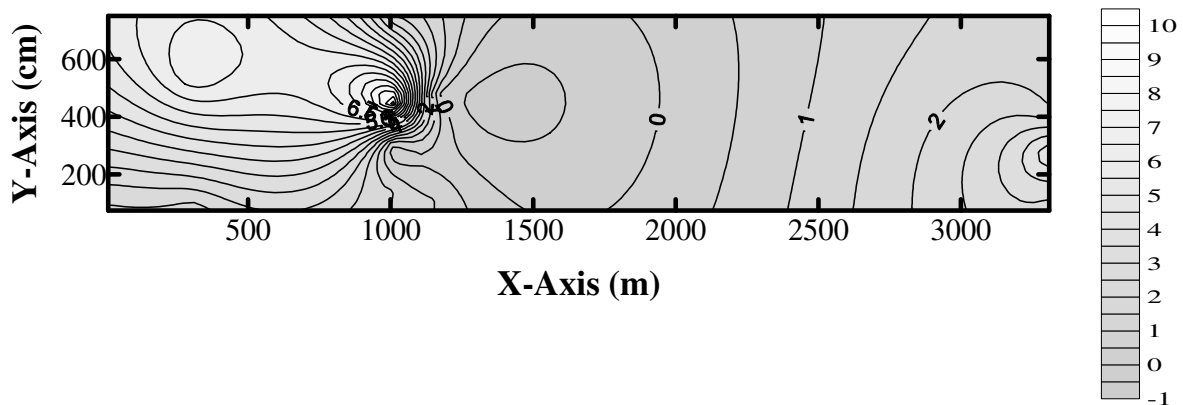
**Fig. 18 Calcium Carbonates Distribution**

According to Figure 19, calcium carbonates are found in 20 soil samples from 39. Calcium carbonates leads to increase the corrosion rate rably.
