## **INVESTIGATION OF PIPELINES' FAILURE PROBLEM OF ELSHABAB PUMPING STATIONS**

**Salah El-Din Sayed Mohamed**

Dr., National Water Research Center, Mechanical and Electrical Research Institute,  
Delta Barrage, Egypt

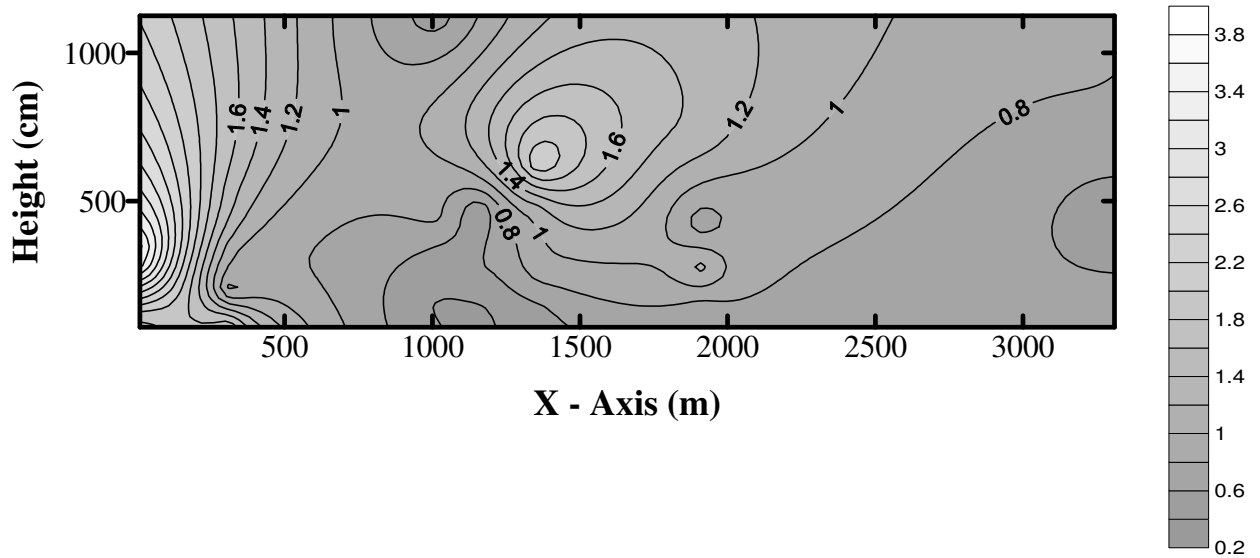
**Fig. 12 Electrical Resistivity Distribution**

The measurements of the soil resistivity are as shown Figure 12 and their values are ranging between 0.2 to 3.8. According to Figure 13 which indicates the relation between the soil resistivity and the corrosion rate [9], the soil resistivity values are found in the extremely corrosive zone. The low values of soil resistivity increase the corrosion rate rapidly.

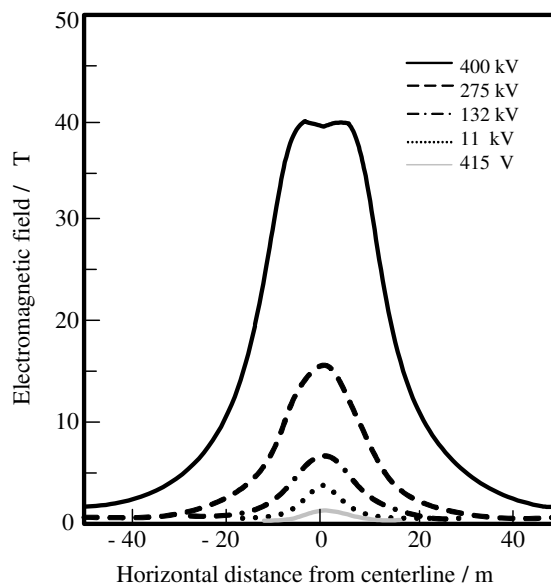
In addition to all the previous conditions, there are power transmission lines in this area. These transmission lines as shown in Figure 14 produce electro-magnetic field which in turn increase the corrosion rate. The value of the electro-magnetic field depends on the distance from the transmission line. The pipelines exist in the affected area [8].

- 1- A good drainage system should be carried out in the area to decrease the water table.
- 2- The corroded parts of the pipelines should be replaced.
- 3- The designed protection and monitoring system should be implemented to monitor and protect the pipelines and to overcome the failure problem.
- 4- The pipeline should be protected with a mish of metallic bond under the medium and high voltage transmission lines.
