HUMAN IMPACTS ON NILE RIVER MORPHOLOGY

ABSTRACT

This paper shows the impacts of human interference on Nile River morphology. A roadway culvert was constructed to connect an island on Nile River to the eastern bank of the Nile had altered river morphology in the vicinity of the island. The paper focuses on, 1) the efficiency of the roadway culvert to pass the normal flow, and 2) the impact of the roadway culvert on river morphology. A one-dimension mathematical model was applied to estimate the flow characteristics and the efficiency of the roadway culvert. It was found that the culvert passes 4% of the flow that would have passed through the eastern branch if the culvert were not existed. As a result, the flow rate in the western channel had increased. Analysis of data indicated changes in river morphology in terms of erosion and sedimentation. In order to restore the efficiency of the eastern channel and to eliminate the side effects of the roadway culvert, a bridge is proposed to replace the roadway culvert. In this case, model results indicated improvements in the hydraulic conditions.

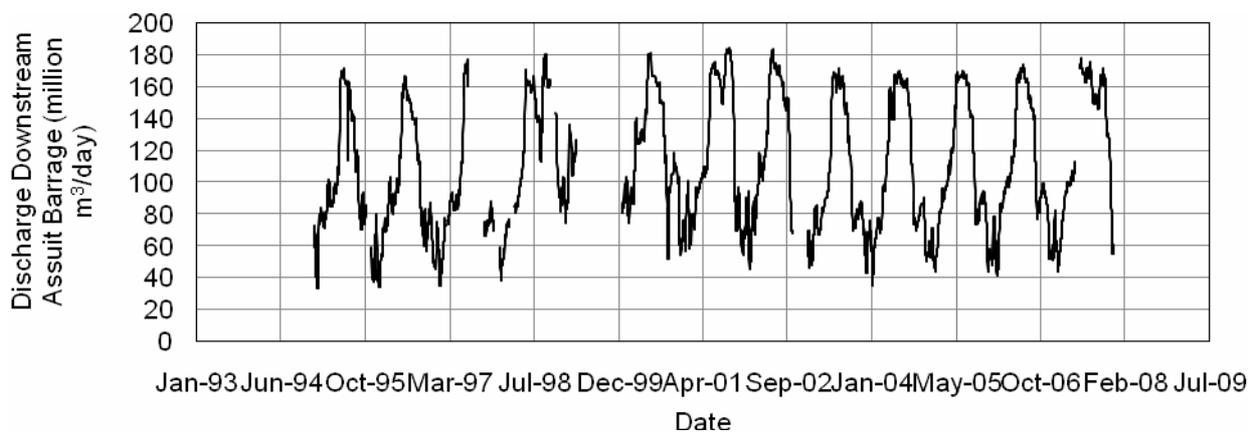
In order to estimate the maximum flow rate in the study reach, hydrology of the Nile River in the fourth reach which extends between Assiut and Delta Barrage was under investigation. Flow rate in the fourth reach is measured at Assiut Barrage which is located 248 kilometer upstream Sannour Island. Figure 1 shows the flow rate variation with time for the period between 1995 and 2007. The figure indicates that flow rate topped 180 million m^3/day four times during this period. Table 1 and Figure 2 show

Figure (1) Variation of Flow Rate with Time Downstream Assiut Barrage

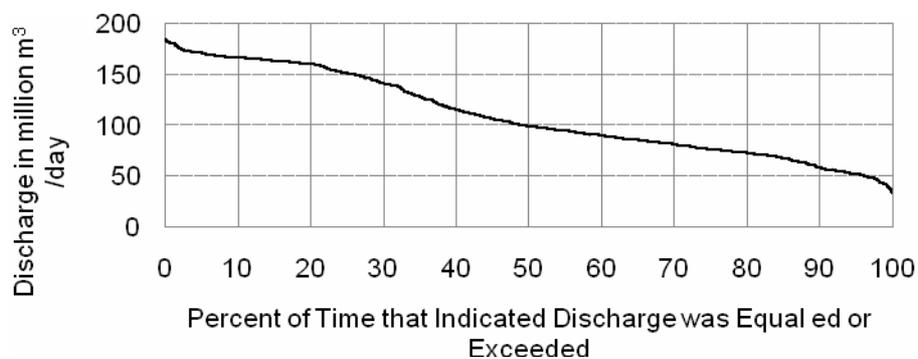
flow duration. From Figure 2 the exceeding probability for flow rate of 180 million m³/day is 1.4%, while, the maximum flow rate occurred during this period was 183 million m³/day.

Figure (2) Flow Duration Downstream Assiut Barrage

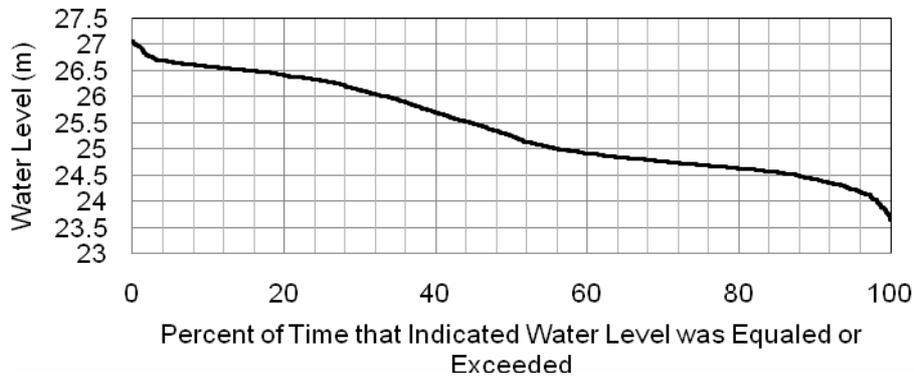
As far as the water level at the island location, this water level was deduced from the data of the water level at Banisuef gage which is located at kilometer 118 upstream Elrodah gage and Beba gage which is located at kilometer 138 upstream Elrodah gage. The water level at the culvert site ranged between 23.7 m. and 27 m. From Figure 3, the water level corresponds to 50% exceeding probability is 25.35 m.

Figure (3) Water Level Exceeding Probability at the Site of Roadway Culvert

A site investigation was carried out to the location of the Sannour roadway culvert. The flow stage at the dam site during the investigation was 25.5 m which has exceeding probability 45% according to Figure 3. The investigation indicated the followings, 1) the culvert has 6 pipes each is one meter diameter, 2) pipes were broken and not properly aligned as in Pictures 1 through 4, 3) pipes bottom level was at or above the water level, and 4) flow stagnation zone existed at the east bank upstream the dam and trapped weeds and wastes. Pictures 1 through 4 show pipes upstream and downstream the culvert.

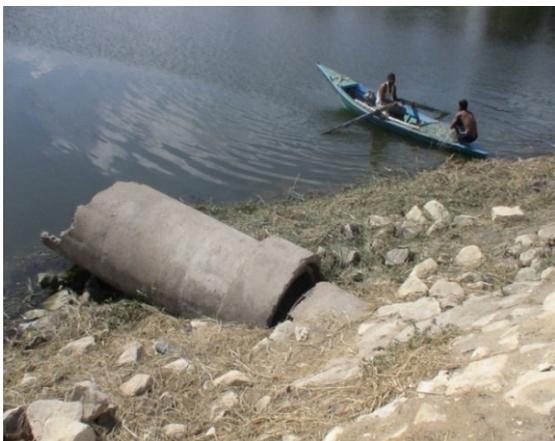
Picture (1) Broken pipes at Upstream

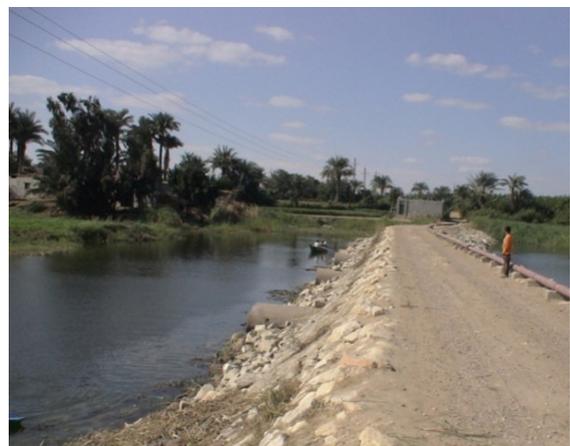
Picture (2) Pipes Configuration Upstream

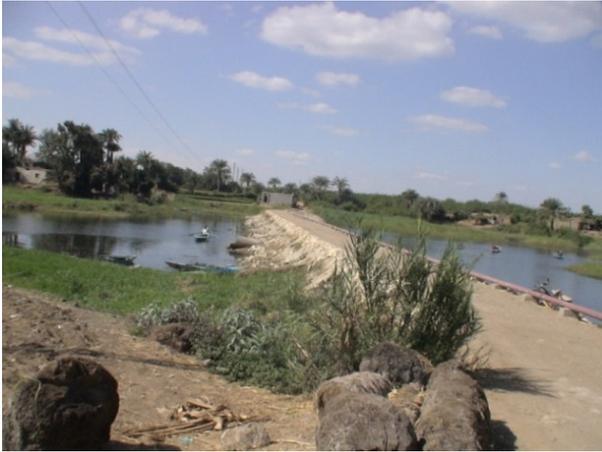
Picture (3) Upstream Roadway

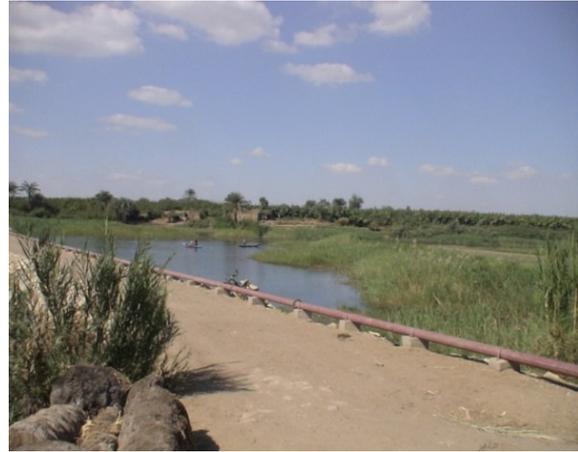
Picture (4) Downstream Roadway

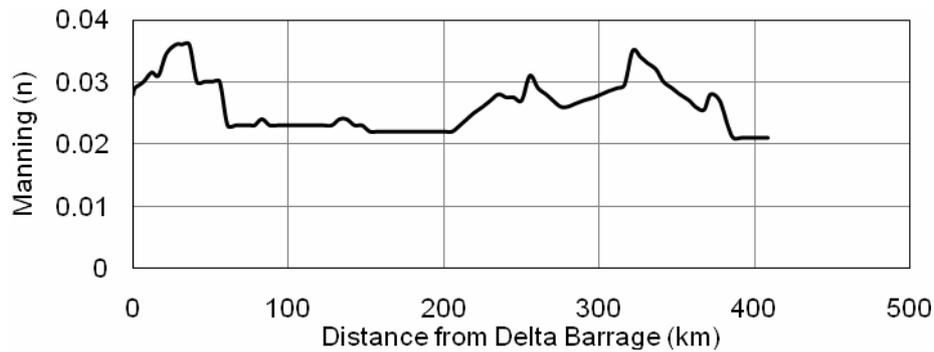
Calibration was carried out at ten staff gages along the reach. Manning coefficient (n) was adjusted at every cross section to match the predicted water surface profile with the observed water surface profile. The Manning coefficient (n) corresponding to the calibrated water surface profile ranged between 0.021 and 0.036 as shown in Figure 4. Figure 5 shows the plot of water surface profile as predicted by the model between Assiut and Delta Barrages and the observed water surface (OWS) at the ten staff gages.

Figure (4) Manning coefficient between Delta Barrage and Assiut Barrage

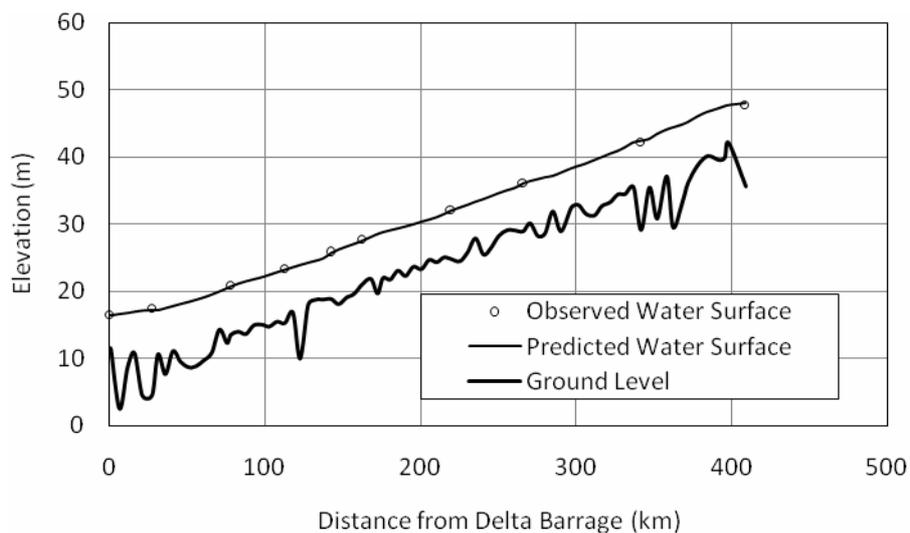
Figure (5) Predicted and Observed Water Surface Profiles between Delta Barrage and Assiut Barrage

From Figure 5, the flow level corresponding to flow rate of 183 million m^3/day at the culvert location was found to be 26.8 m.

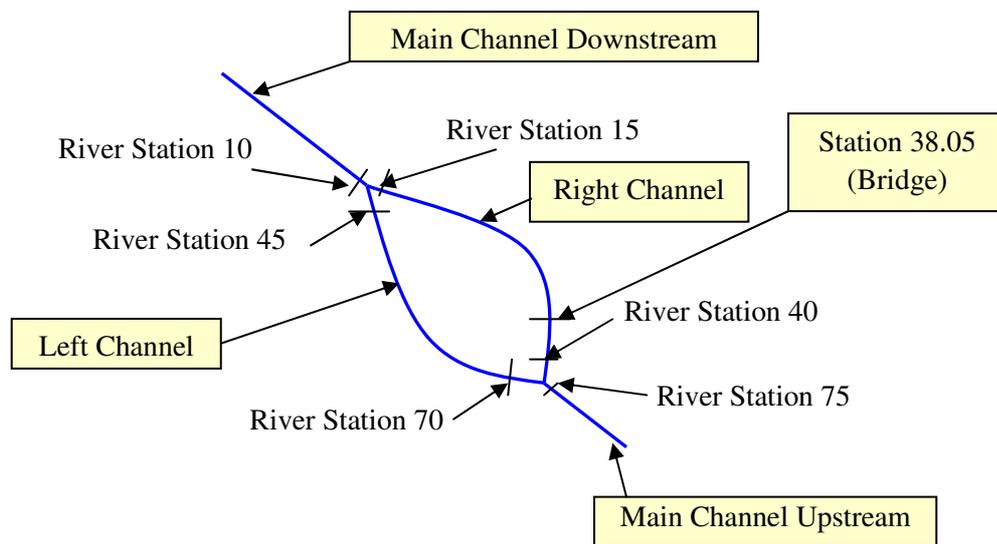
The numerical model predicted the flow in the two channels surrounding Sannour Island assuming that culvert did not exist. It was found that the maximum discharge that can be passed through the eastern channel is 180 m^3/sec which is equal to 15.5 million m^3/day as shown in Table 2 and location of river stations as indicated in Schematic 1.

**Schematic (1) Location of River Stations**

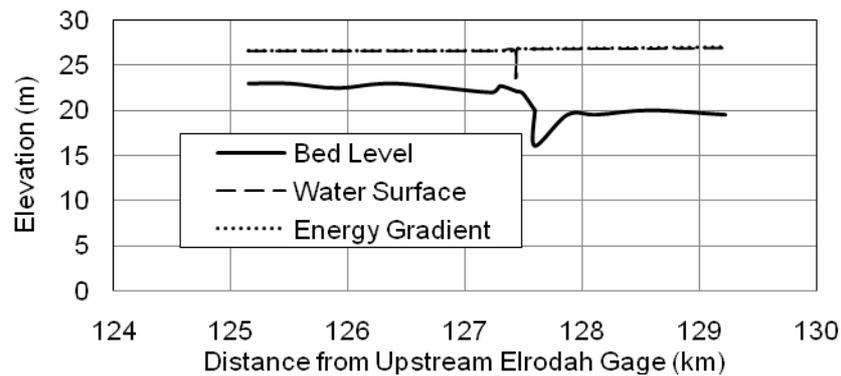
Figure (6) Flow Analyses in Case of Culvert as Predicted from the Mathematical Model

The analysis using the numerical model indicated that current configuration of culvert allows only a discharge of $7 \text{ m}^3/\text{sec}$ which is equivalent to 0.6 million m^3/day . Water surface profile and energy gradient is as shown in Figure 6. Also, heading up of 19 cm occurred upstream the culvert as shown Table 3.

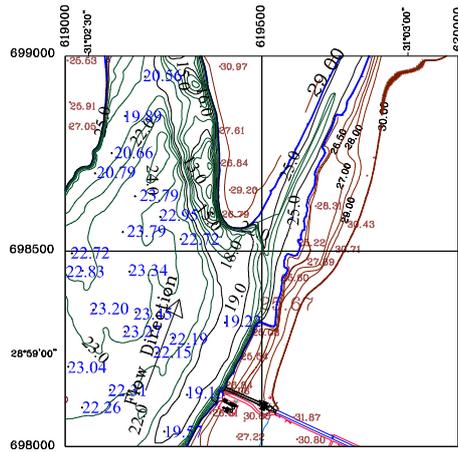
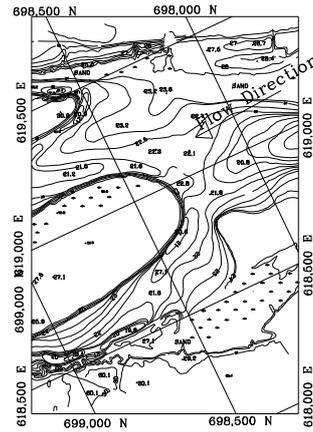
The most significant changes in river morphology took place in the western bank at the upstream end of the study reach (Maps 2 and 3). An island existed in 1982 in the western channel was attached to the western bank at its upstream end in 2003. That is, the effective flow width had dropped significantly. The attachment of island can be in part attributed to channel adjustments in this region, since upstream the study reach the river tends to follow a straight path. Disappearance of the island and the reduction of flow in the eastern branch of Sannour island had increased the flow in the western channel and had changed the location of the thalweg line in the western channel. The thalweg line follows a path very close to the eastern bank. Then, shifts towards the western bank towards the downstream of the island length, Figure 7.

Map (2) Upstream Sannour Island in 1982

Map (3) Upstream Sannour Island in 2003

The thalweg line location had not changed significantly in the eastern channel. The location of the thalweg line of 2003 coincided with that of 1982 except at the middle of the channel where the thalweg line of 1982 was close to the eastern bank as shown in Figure 8.

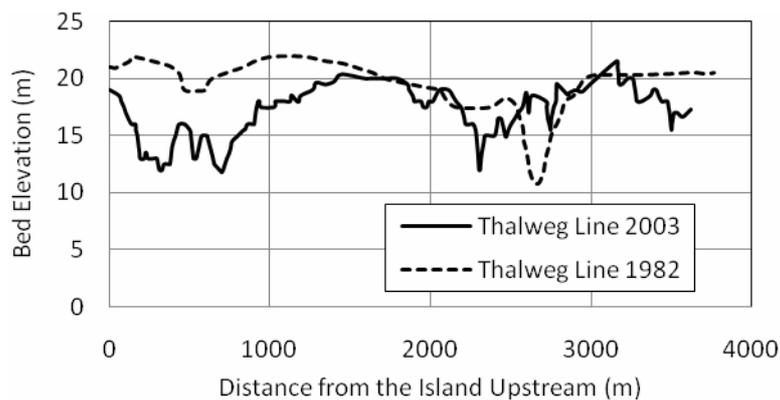
The western channel had undergone noticeable erosion between 1982 and 2003. The upstream end under-went erosion of up to 8.11 meters, however, deposition took place at the downstream end as shown in Figure 9. The magnitude of deposition did not exceed 7.77 meters near the downstream end. Based on Figure 9, it can be concluded that erosion was dominant on the western channel.

Figure (9) Thalweg Lines of Years 1982 and 2003 for the Western Branch at Sannour Island

section, resulted in the increase in bed particles mobility and bed erosion in the western channel. Aggradation in the west bank of the western channel had forced the flow to change its course towards the east bank and increased the incision near the east bank as in Figure 9.

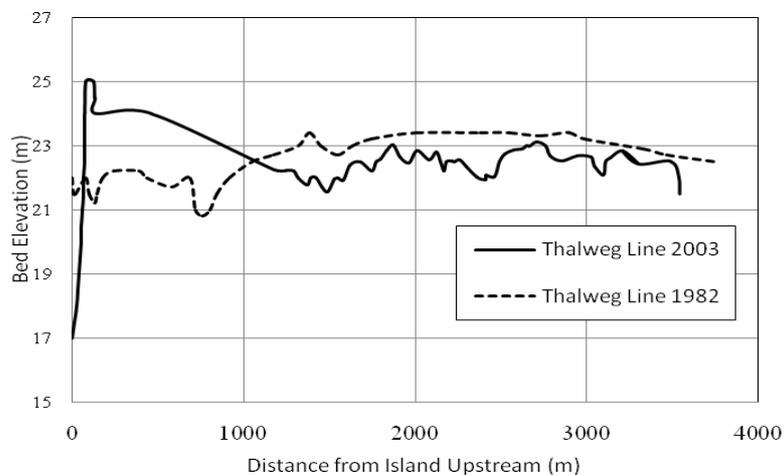
In the eastern channel, erosion took place at the upstream apex of the island in 2003. The roadway culvert had increased deposition at the upstream end of the culvert up to 2.3 meters as shown in Figure 10. Downstream the culvert, erosion did not exceed 1.4 meters at maximum.

Figure (10) Thalweg Lines of Years 1982 and 2003 for the Eastern Branch at Sannour Island

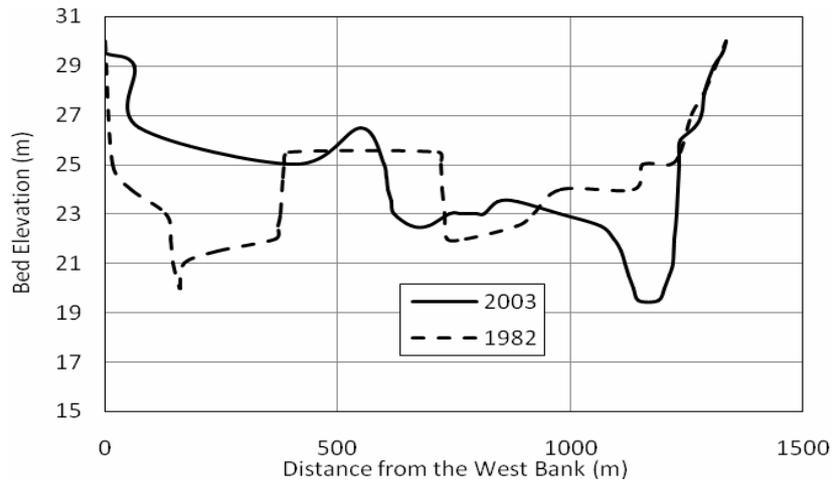
It can be concluded that the existing of roadway culvert and extensive deposition on the west bank of the main channel (Figure 11) had accelerated the erosion in the west channel of Sannour Island. The flow in the western channel was in the process to accommodate a new location for the thalweg line towards the east bank, thus, possible future erosion in the east bank.

Figure (11) Cross Sections of Years 1982 and 2003 at Kilometer 128 Upstream Elrodah Gage

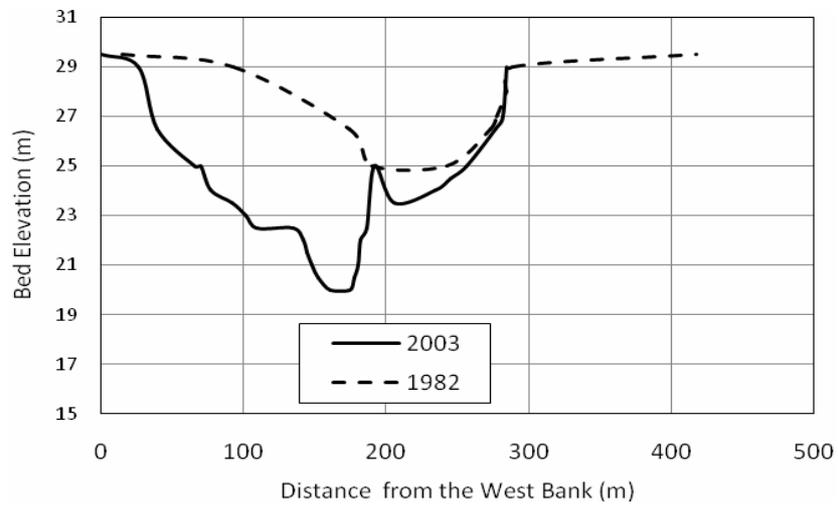
Figure (12) Cross Sections of Years 1982 and 2003 at kilometer 127 Upstream Elrodah Gage (Eastern Channel)

Despite the erosion in the east channel, flow in the east channel was stagnant and weeds can be observed covering wide area in the east bank. The roadway caused significant deposition in the upstream of the roadway. The presence of weeds may trap sediment in the future which may lead to the clogging of the branch. Figures 11 through 13 show cross sections of years 1982 and 2003 at kilometers 127 and 128 upstream Elrodah gage. Locations of these cross sections are identified in Map 1.

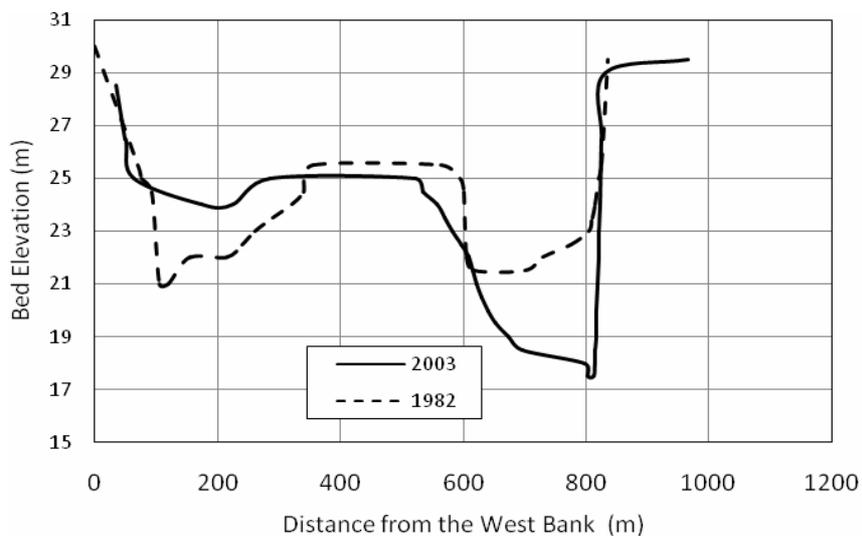
Figure (13) Cross Sections of Years 1982 and 2003 at kilometer 127 Upstream Elrodah Gage (Western Channel)

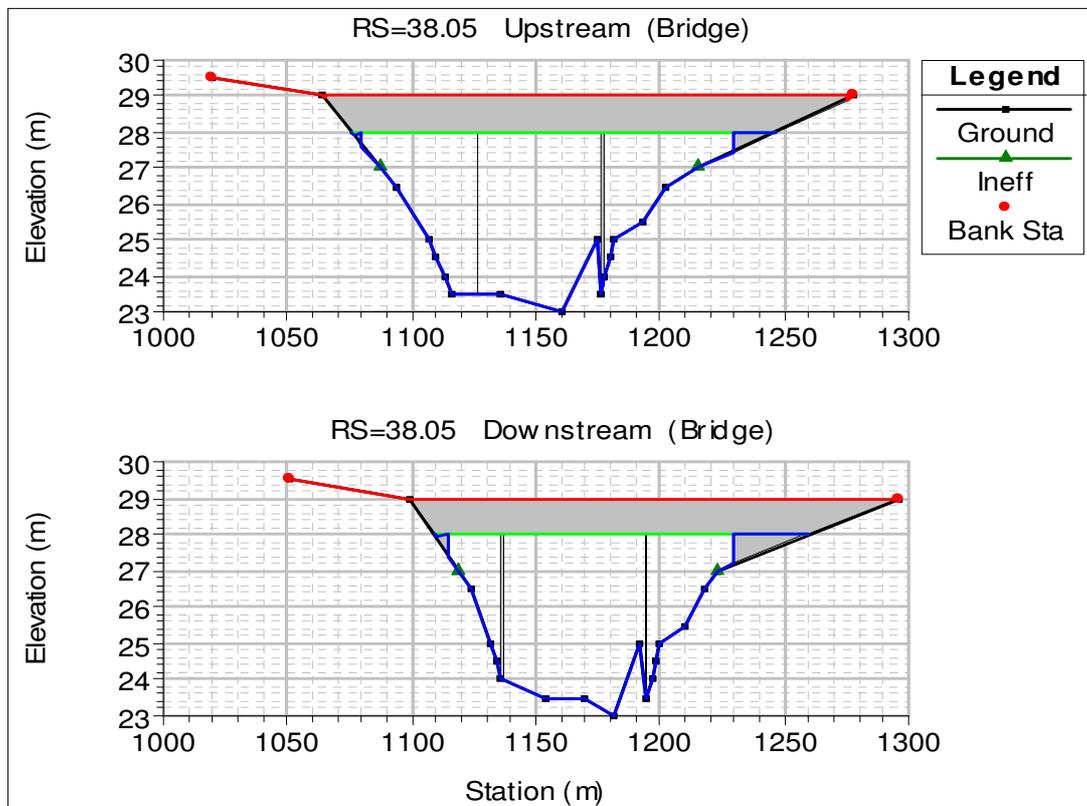
Modification of the existing culvert by increasing the pipes to 12 pipes and increasing the diameter to 2 meters did not significantly increase the flow to the eastern channel. Therefore, replacing the culvert by bridge might be considered as an alternative solution. The HEC-RAS model is used to test this alternative. The proposed bridge has a width of 9 meters, two piers, and two abutments. This configuration will create three bridge openings (Figure 14) at station 38.05 which is located as indicated in Schematic 1. The model results showed that present configuration can handle the maximum flow of 180 m³/sec. Figure 15 shows that the heading-up during the maximum flow will not exceed 10 cm as a result of the bridge as shown in Table 5.

RS is the River Station, Ineff is the Ineffective Flow Area, and Bank Sta is the Bank Station

Figure (14) Cross Sections of the Proposed Bridge

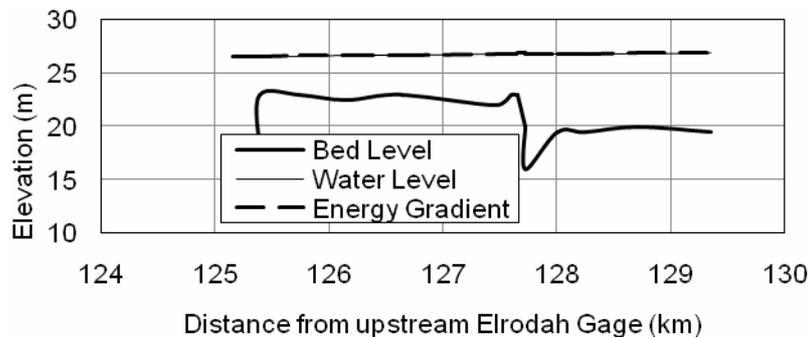
Figure (15) Bed Level, Flow Level and Energy Gradient in Case of Bridge

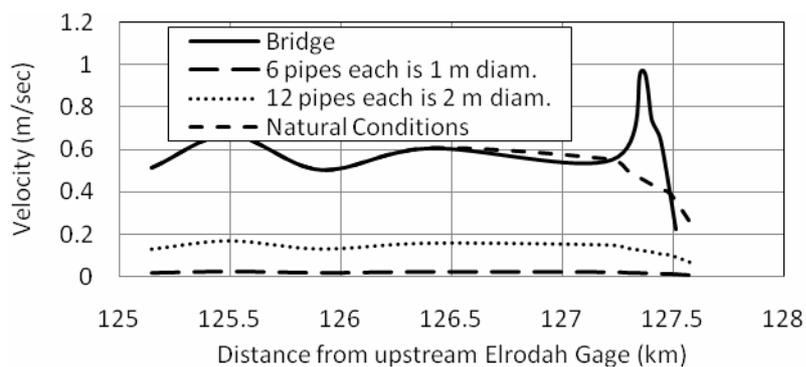
Comparing the output of the model for the four cases considered in the analysis, these are, 1) original conditions (no culvert), 2) 6 pipe culvert, 3) 12 pipe culvert, and 4) bridge, showed that, flow velocity in the eastern channel in case of bridge is close to the flow velocity in the natural conditions (no culvert) as shown in Figure 16.

Figure (16) Flow Velocity for the Different Study Cases
