DIAGNOSIS VIBRATION PROBLEMS OF PUMPING STATIONS: CASE STUDIES

S. M. Abdel-Rahman and Sami A. A. El-Shaikh

Mechanical & Electrical Research Institute, National Water Research Center, Ministry of Water Resources & Irrigation, Delta Barrage, Egypt

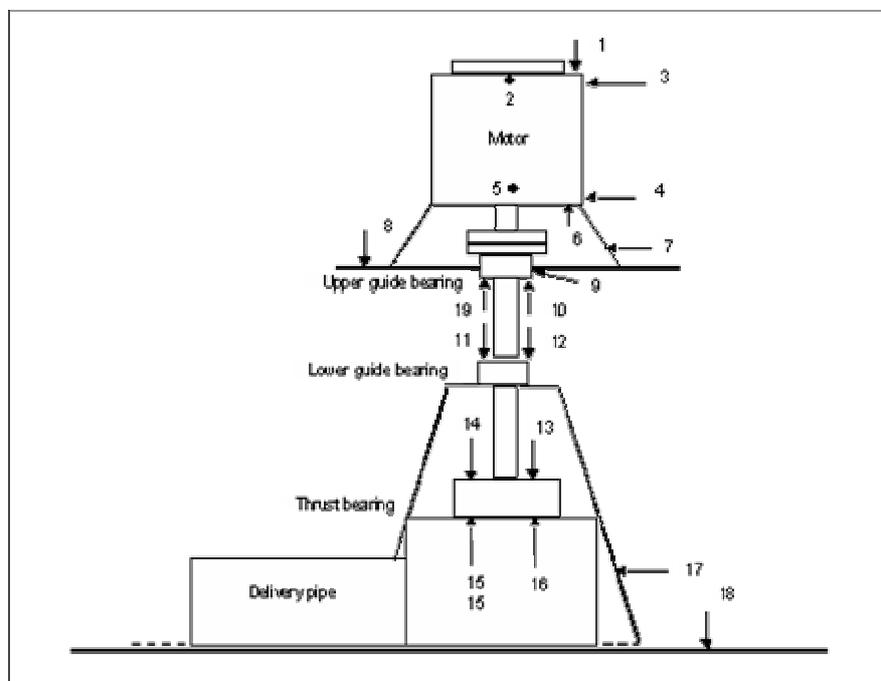
Fig. 1 Measurement locations for vibration of Awlad-Tuke (2) Pumping Station

Vibration measurements were done on a vertically mounted pump of axial flow type in the field at Awlad-Tuke pumping station no.(2). The pump station was in the early stage of operation where high level of vibration and noise was observed besides bearing failure problem occurs frequently during the final submission of the plant (**Abdel-Rahman et al., [13]**). Measurements were done on six pump units at no load conditions where the motor was disconnected completely from the pump via the coupling, and at full load condition. For no load condition, vibration measurements were done on 8 locations on the motor where for full load condition, vibration data were recorded on 19 locations on the motor, pump, bearings, and foundation in the axial and radial directions as shown in **Fig. (1)**.

Overall vibration measurements done on the pumping units during the normal operating conditions showed that vibration level is not permissible on some locations at the units. To determine the exciting sources of vibration and to reveal whether the high vibration level is due to excitation forces or due to resonance of the system, the motor was disconnected from the pump system and elevated short distance above to isolate the motor from any resonance source of the pump or structure. The motor was operated at this condition and vibration level was measured. Vibration levels at no load conditions are shown in **Fig. (2)** for the six motors of the pumping units. It is apparent that the maximum vibration level during no load conditions occurred at the motor non-drive end in the radial direction on both sides of the motor at locations 2 & 3.

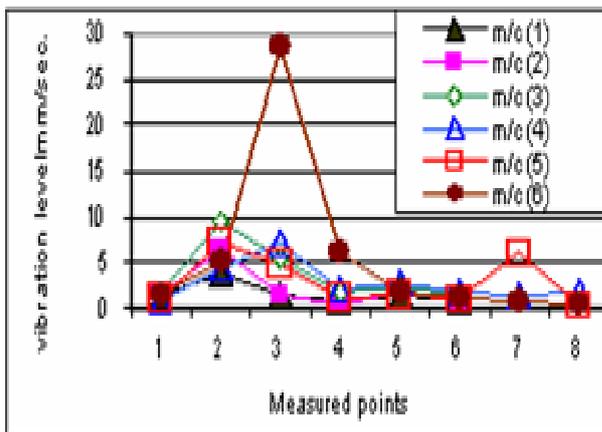
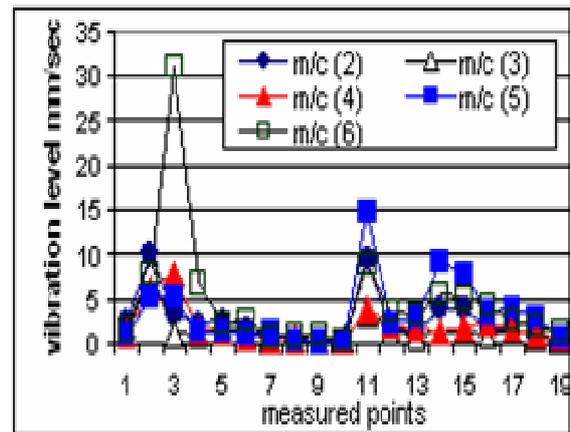
**Fig. 2 Vibration levels (mm/sec) at no load**   **Fig. 3 Vibration levels at full load**

Maximum vibration level for no load conditions occurs at point 2: for unit 1 is 4 mm/sec, for unit 2 is 6.5 mm/sec, for unit 3 is 9.5 mm/sec, for unit 4 is 7.3 mm/sec, for unit 5 is 7 mm/sec, and for unit 6 are 5.2 mm/sec at point 2 and 28.4 mm/sec at point 3. However, maximum vibration level measured at point (3) for pump unit (2) is of level 29 mm/s.

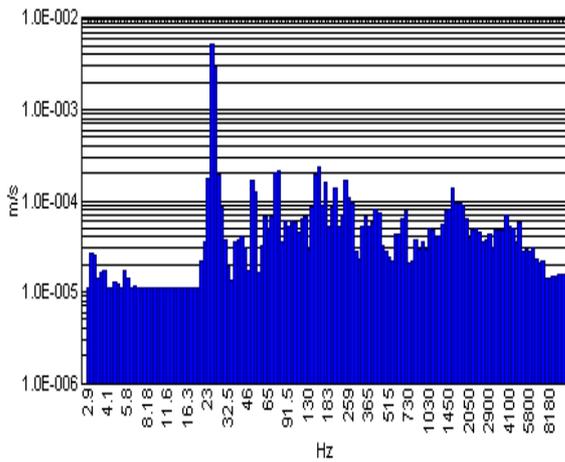
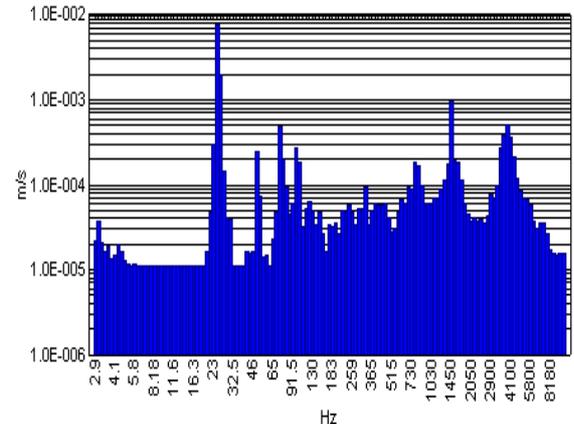
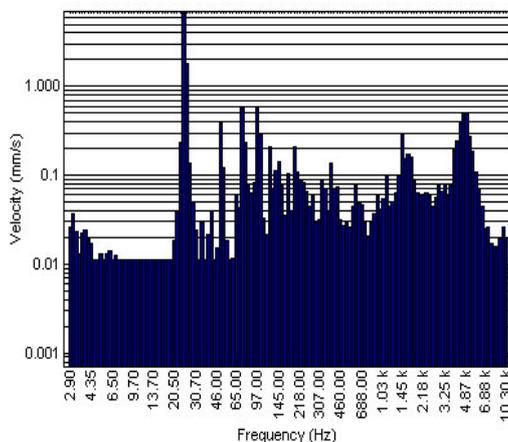
Fig. 4 Spectrum at pt. 2 of m/c 2 at no load   **Fig. 5 Spectrum at pt. 2 of m/c 6 at no load**

point 2 for two pumping units 2 & 6 at both no load and full load conditions are shown in **Figs. (4-7)**. Each machine has its distinct spectra at no load and full load conditions. For load conditions, high non-harmonic frequencies are found due to hydraulic disturbance in the pumps, which were not found in no-load conditions. Spectra of no-load conditions show peaks at the running speed of the motor and its harmonic, where spectra of load conditions show peaks at the running speed of the motor in addition to vane passing frequency and pump bearings frequencies.

Summary of the results show that there are problems at upper and lower bearings of the motors, unbalance of the rotors, upper and lower guide bearings of the pumps, and misalignment of the shafts. These problems were found in different levels in the different pumps. For the operation requirement, faulted components must be replaced completely and the pumping station should be operated under inspection and regular maintenance to bring back the pumps to a good condition capable of performing their duty in safe operation and minimum maintenance costs.

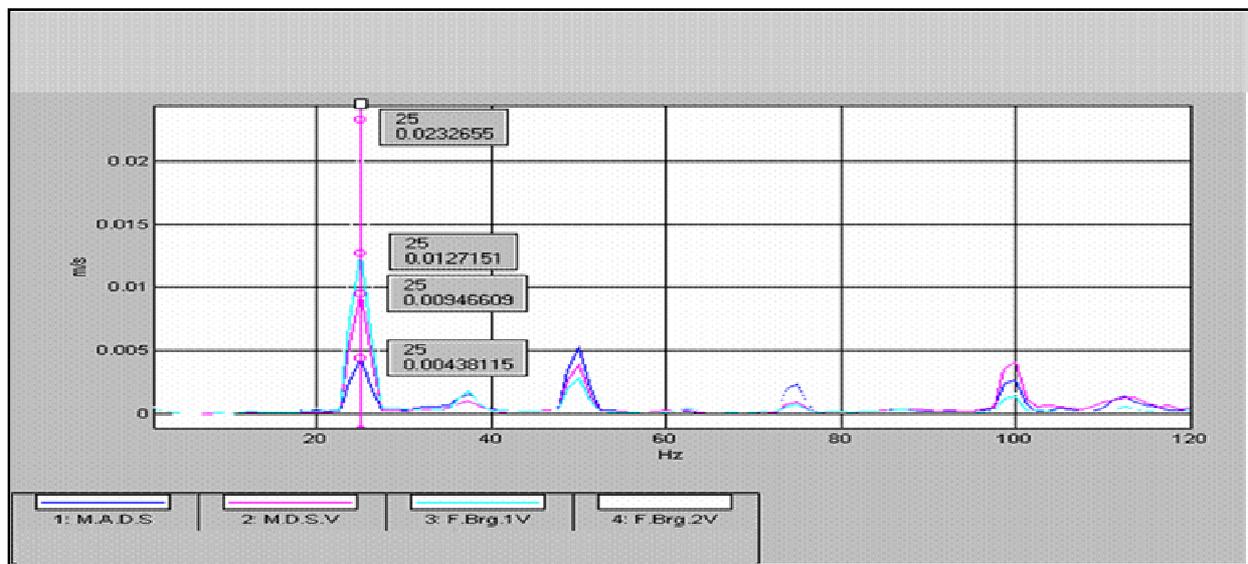
Fig. (8) Spectrums in the Vertical direction Shows highest peak at fundamental speed

In this case a pump system consists of a motor, gearbox, and pump was measured and analyzed, where the motor speed is 1492 rpm and electrical power is 110 kilowatts. Overall vibration levels measured and analyzed and compared with (ISO 10816-1) showed vibration peaks of level 24 mm/s measured at the motor drive end next to the gear box. This high vibration in the not permissible zone of ISO 10816-1 indicates a great problem for the pump system. It is not safe and dangerous and not allowed to operate the pumping system at this running condition. The pump system was shut down to diagnose the problem and fix it.

Dynamic analysis was done in the axial and radial direction to determine exciting frequencies, and evaluate sources of high vibration. Vibration spectrum, as shown in **Fig. (8)**, showed high vibration levels in the axial and radial directions of maximum amplitude 23.3 mm/s at the motor speed (25 Hz). This situation indicated severe unbalance problem for the motor fan. Balancing was done to the motors shaft-fan-coupling and vibration level was measured and analyzed. Vibration amplitude decreased greatly to 1.8 mm/s in the safe and allowable zone according to the ISO 10816-1 and dynamic performance enhanced greatly as vibration level decreased 92%.

- Unbalance problem of a pumping system produces high vibration of level 4 mm/s; however, balancing of the unbalanced motor fan enhances dynamic performance greatly as vibration level decreased 92%.

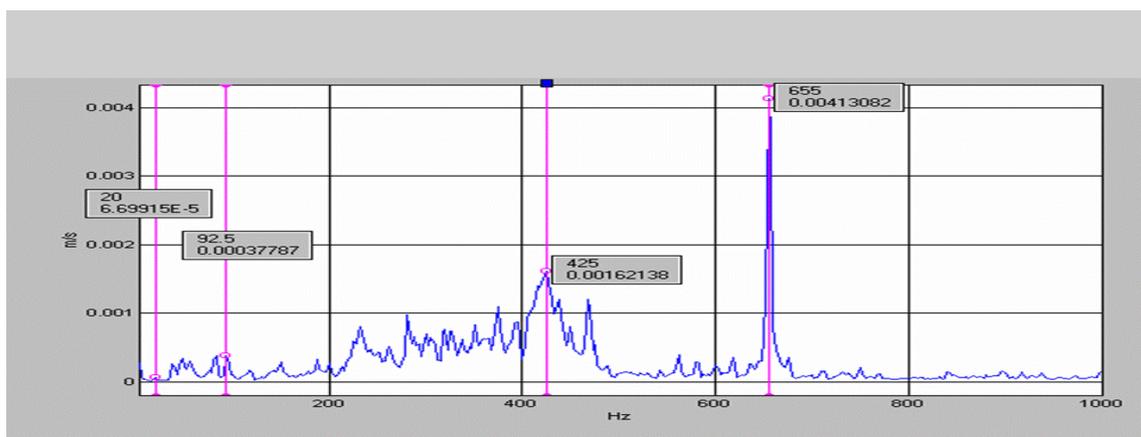
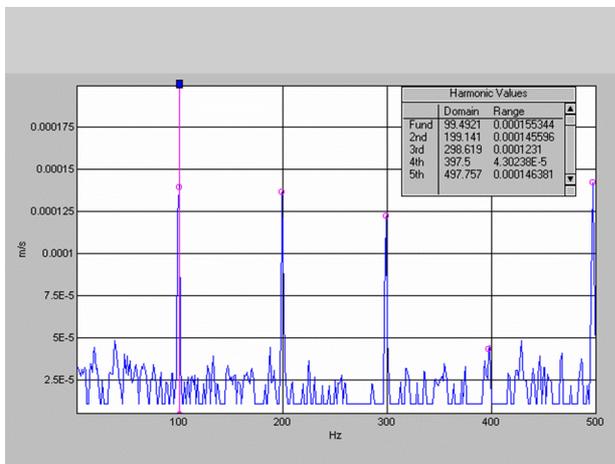
**Fig. (9) Auto spectrum of the Motor Inboard Bearing Radial (Before replacement)**

components of each bearing was calculated and is shown in **Table (1)**. Overall vibration level measured is 4.5 mm/s which is beyond the allowable limit according to ISO 10816-1. Dynamic analysis was done and auto spectrum showed different vibration peaks of level 4.1 mm/s at 655 Hz, level 1.6 mm/s at 425 Hz, as shown in **Fig. (9),** implying either a hydraulic problem or a bearing problem. Also, constant percentage bandwidth (CPB) confirmed the same trend of high acceleration vibration levels of maximum amplitude 13 m/s^2 at 655 Hz, as shown in **Fig. (10-a).**

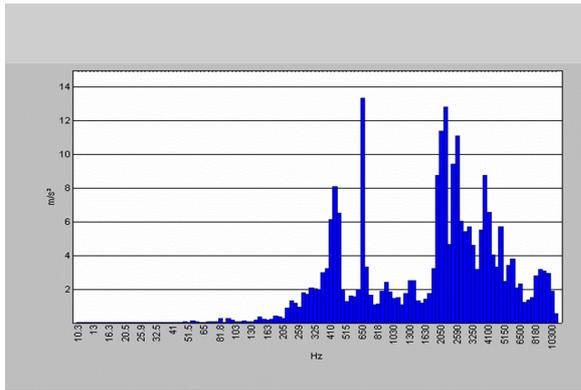
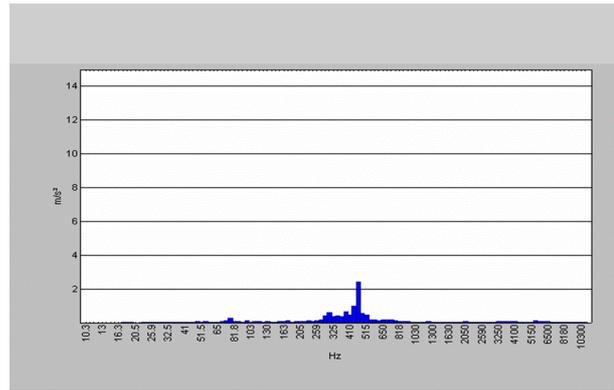
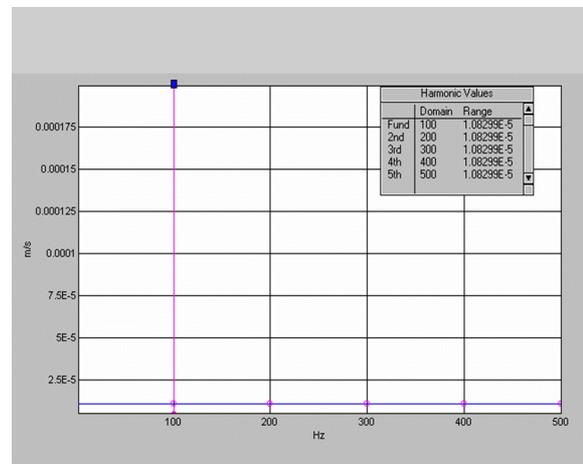
Fig. (10) CPB Spectrum of the Motor Drive end Bearing Radial

Envelope spectrum was done and showed vibration peaks at 100 Hz and its harmonics, as shown in **Fig. (11-a)**, implying a defect of the outer ring of the motor drive end bearing according to the calculated exciting frequencies in Table (1). The damaged bearing was replaced and vibration measurements were done showing improvement in the dynamic performance, where vibration peaks at the excitations frequencies were almost insignificant, as shown in **Figures (10-b)** and **(11-b)**.

- Envelope spectrum proves a good tool for diagnosing bearing problems. A damaged bearing produces high vibration of level 4.1 mm/s vibration velocity and 13 m/s^2 acceleration vibration. Replacing the damaged bearing enhances dynamic behavior and reduces vibration level 95%.

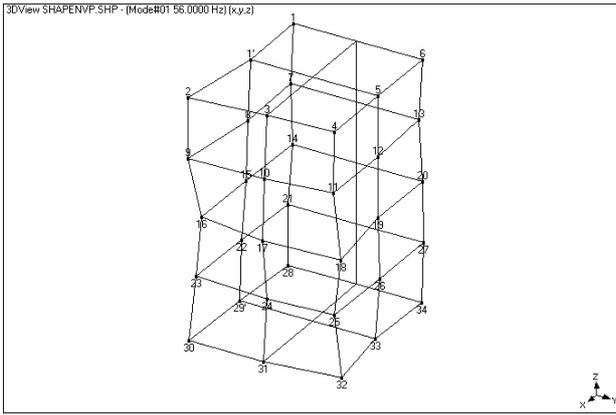
Fig. (12) Mode shape no.1 for the variable speed pump system

The trend of using variable speed drives in pumping station to increase pump efficiency and reduce energy losses, has motivated the authors to study dynamic behavior of such variable speed pump systems at different operating conditions. A variable speed pump system model of 15 kW power was dynamically tested and analyzed in the laboratory, where unbalance problems of different degrees were simulated. Experimental modal testing was done on the pump system to determine its dynamic characteristics. **Table (2)** summarizes the modal parameters of the pump system where the fundamental natural frequency is 56 Hz (3360 rpm) and damping 61%. It is very important to define the natural frequencies of the system to determine the optimum operational speed that satisfies water requirements and works away from the resonance problem. It is apparent that the running speed up to 3000 rpm is safe. Operation at 3360 rpm is dangerous; however, damping coefficient at this speed is high

(60%) and capable of suppressing any excessive vibration level. So, the only resonance problem that may arise from varying speed of that motor is running at 3360 rpm and structural modification is required to improve dynamic behavior of the motor if operation at this speed is a must. First bending mode shape of the motor is shown in **Fig. (12)**, where sensitive nodes are defined to implement any modifications that enhance its structural properties.

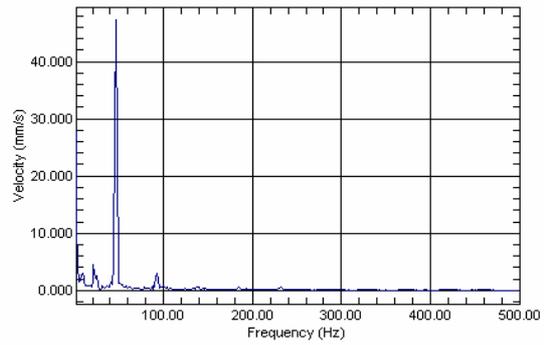
Fig. (13) Spectrum measured at severe unbalance at 2500 rpm

Forced vibration tests were done at different speeds of the motor at 1500, 2000, and 2500 rpm where vibration levels were measured at normal operating condition. Unbalance problem of different grades from minor to moderate to severe were simulated, by adding different weights in different planes, to determine their effect on vibration level during operation at different speeds. Results of vibration measured at different speeds and different operating conditions are summarized in **Table (3)**. Vibration levels measured at normal condition are within allowable standard limit in the order of 2.65 mm/s and did not change much with varying speed. At normal operating condition, vibration level increased 3.8% by increasing running speed 66%. On the other hand, vibration level measured at minor unbalance problem is of level 5.0 mm/s (outside allowable standard limit) at 1500 rpm. However, vibration level increases 58% by increasing speed 66% at minor unbalance problem. For moderate unbalance problem, vibration level increased 98.0% by increasing speed 66%. Moreover, vibration level increased dramatically 200% by increasing speed 66% at severe unbalance problem. At 1500 rpm speed, vibration level increased 90% than normal operating condition due to minor unbalance, 210% due to moderate unbalance, and 400% due to severe unbalance. However, at 2500 rpm speed, vibration level increased 190% due to minor unbalance, 450% due to moderate unbalance, and 1400% due to severe unbalance.

A spectrum measured on the motor at speed 2500 rpm is shown in **Fig. (13),** showing simulated severe unbalance at 2500 rpm, where a single peak of high vibration amplitude (45 mm/sec) is measured at the exciting frequency. It is obvious that vibration level increases with increasing speed and the vibration level increases greatly with increasing excitation sources in the system. Vibration level increased greatly with increasing grade of unbalance. Also, at the same grade of unbalance, vibration level increased with increasing running speed. Periodic maintenance and inspection of variable speed pump systems is important to avoid sudden breakdown and failure.
