## **INVESTIGATION OF PIPELINES' FAILURE PROBLEM OF ELSHABAB PUMPING STATIONS**

**Salah El-Din Sayed Mohamed**

Dr., National Water Research Center, Mechanical and Electrical Research Institute,  
Delta Barrage, Egypt

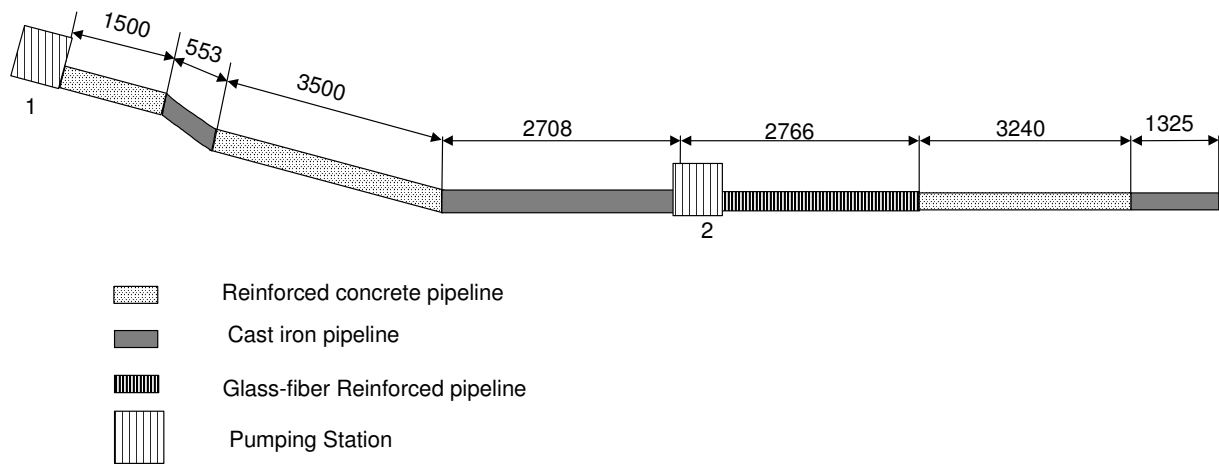
**Fig. 2 Total pipeline parts**

The pipelines were installed in 1981. The total length of the pipeline is 15,592 meters and its diameter is 1.5 meters. The length and material of each pipeline connection are shown in Figure 2. The studying area is only between El-Shabab pumping stations number 1 and 2. The pipelines in the studying area include four parts. The first part is a pre-stressed concrete pipeline (PSCP) which has 1,500 meters length, the second part is a cast iron pipeline which has 553 meters length, the third part is a pre-stressed concrete pipeline (PSCP) which has 3,500 meters length, and the fourth part is a cast iron pipeline which has 2,708 meters length. The third part is the most infected one and it suffers from severe corrosion and failure at different positions. The total thickness of the (PSCP) is 18 centimeters consisting of 4 millimeter thickness steel

pipe covered by a 6 centimeters concrete layer; in addition the steel bars net which is covered by another layer of concrete 10 centimeters thick.

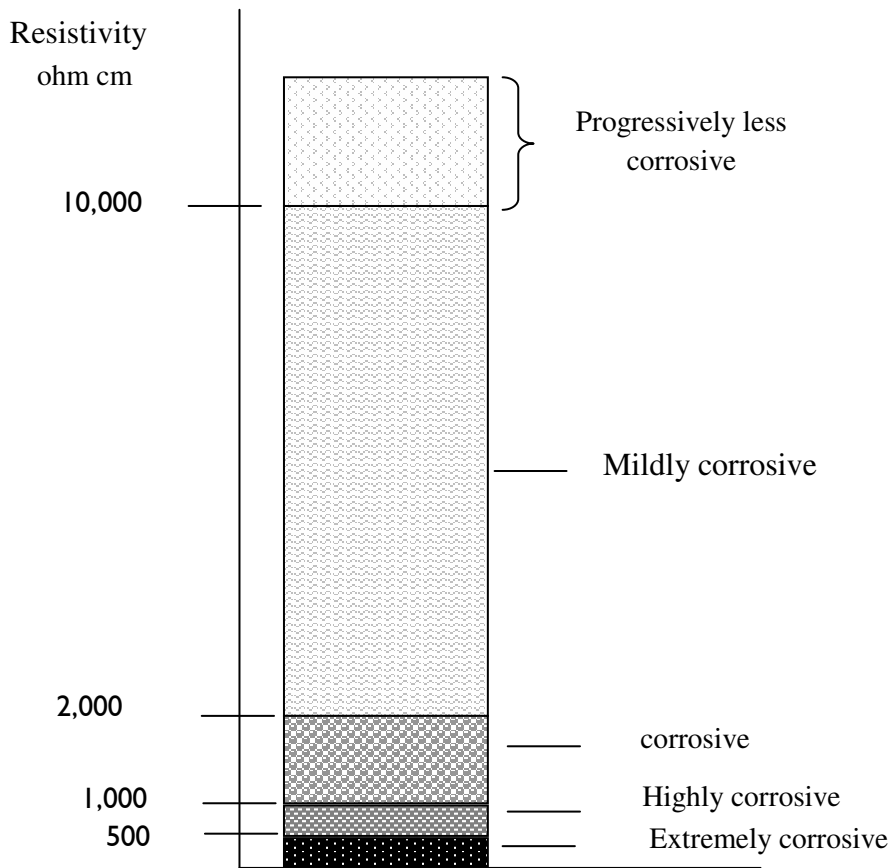
**Fig. 13 Relation between soil resistivity and corrosion rate**

The measurements of the soil resistivity are as shown Figure 12 and their values are ranging between 0.2 to 3.8. According to Figure 13 which indicates the relation between the soil resistivity and the corrosion rate [9], the soil resistivity values are found in the extremely corrosive zone. The low values of soil resistivity increase the corrosion rate rapidly.
